Environmental Site Characterization Report

South Kelso Railroad Crossing Project

Kelso, Washington

November 30, 2018

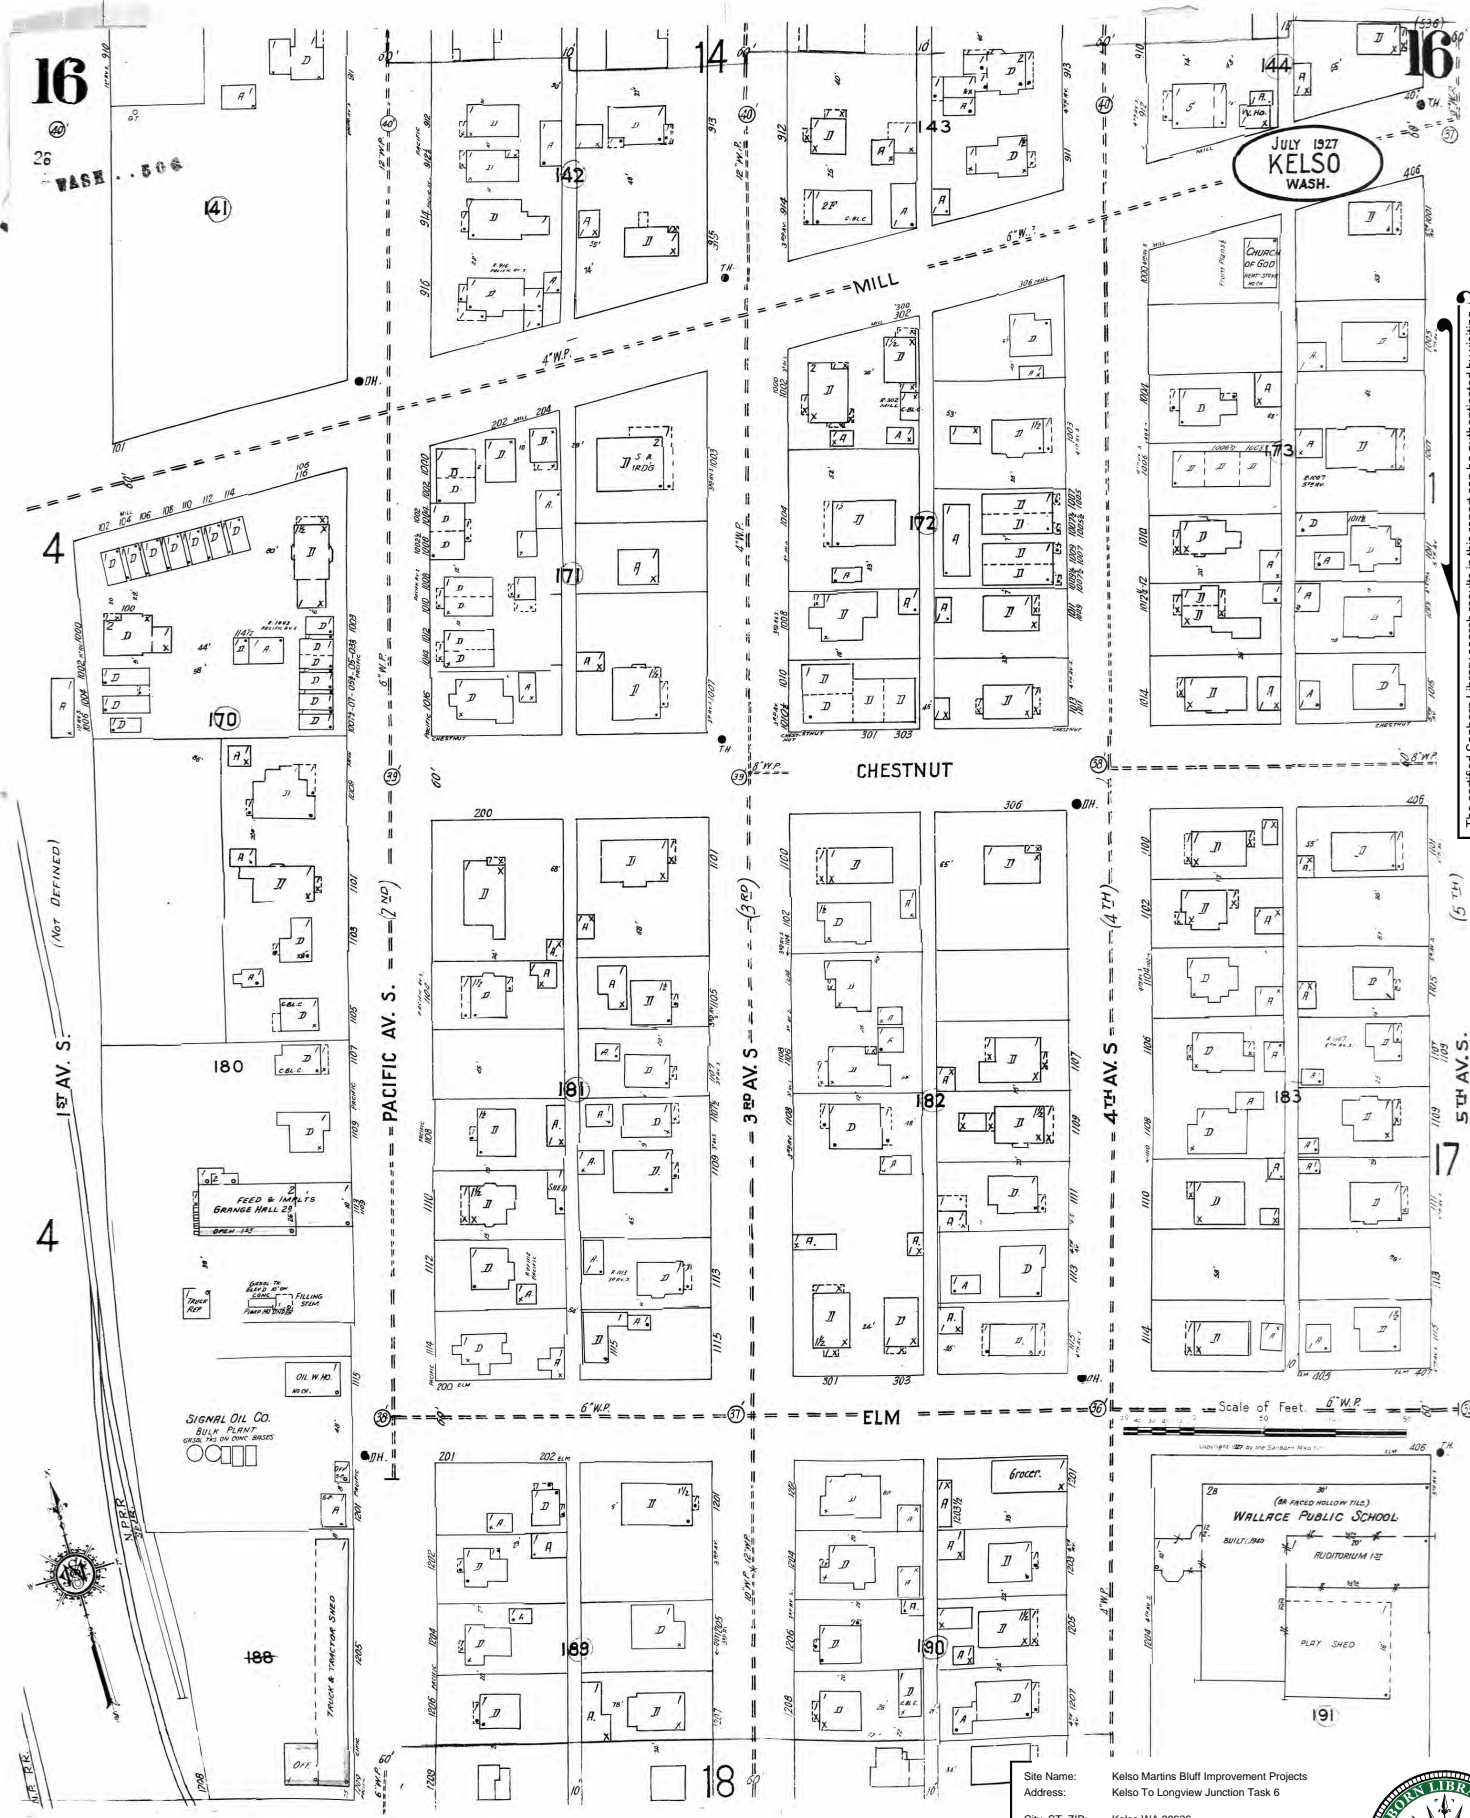
1949 Certified Sanborn Map

- 1949: A store and residential properties and associated garages were located near the Yew Street at-grade crossing. Additional residences were present near the Mill Street at-grade crossing. The Standard Oil Company site shown on the 1923 map was depicted as a truck and tractor shed. Signal Oil Company Bulk Plant, including at least 5 ASTs and an oil warehouse, was adjacent to the truck and tractor shed to the north. Feed & Implements and Grange Hall was depicted north of Signal Oil Company Bulk plant and included a truck repair building, elevated gas tank, and filling stem. 2nd Avenue South had been renamed to South Pacific Avenue.
